Electrostatic Discharge on a Compressor Train

John Winterton

Principal Engineer
Bently Nevada Corporation
e-mail: john.winterton@bently.com

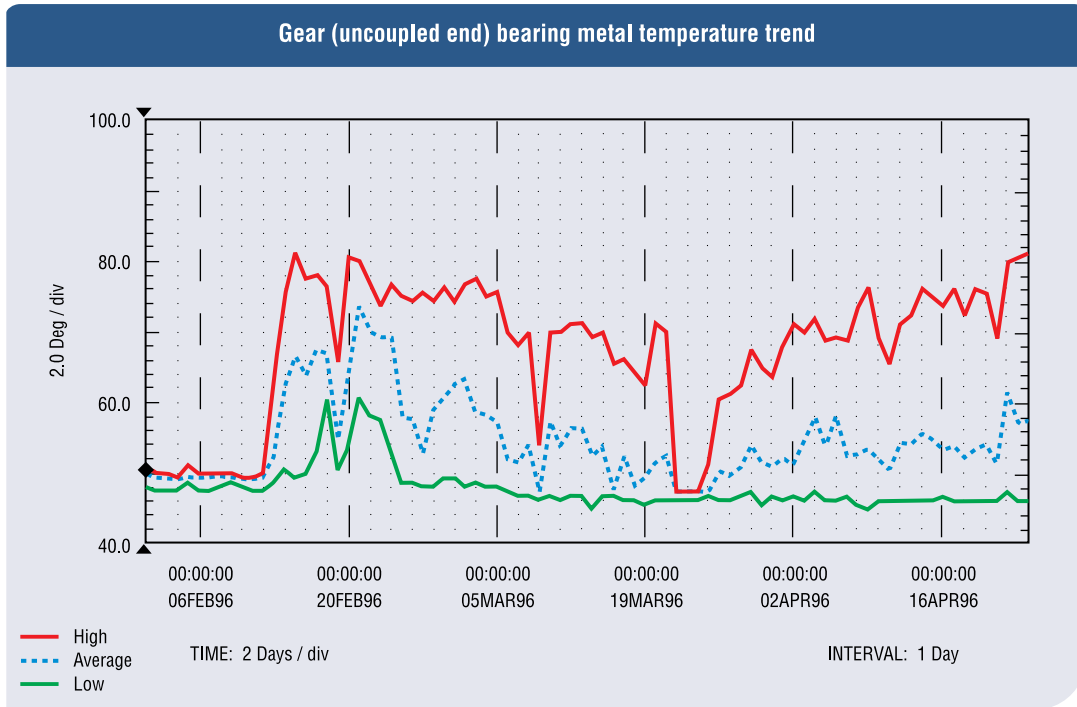
Figure 2.

Figure 2 shows the trend of bearing metal temperatures at the gearbox low-speed “blind” (uncoupled end) radial bearing (Bearing 6 in Figure 1). The plot shows a marked increase in temperature on or about 12 February as well as a very slight upward trend starting in late March. Significant and of short duration decreases in temperature are due to scheduled shutdowns or process changes affecting machine load.

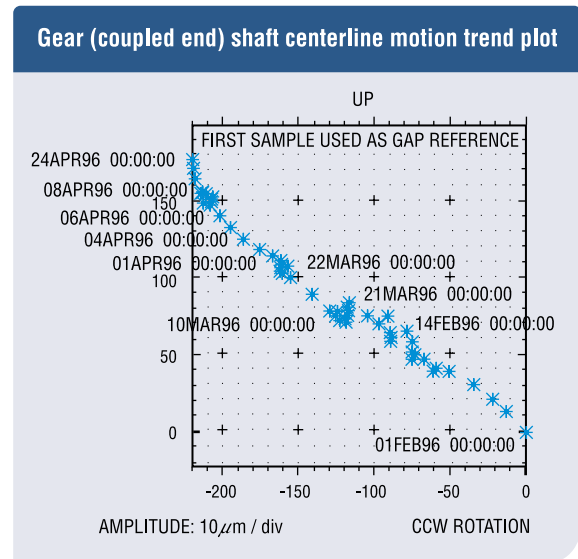
Figure 3.

Figure 3 is the plot of shaft centerline motion at the gearbox low-speed shaft extension bearing (Bearing 5 in Figure 1). The plot indicates approximately 280 μm (11 mils) shaft movement since 1 February 1996. This is an excess of 25% from the nominal bearing clearance of 229 μm (9 mils).

The customer was advised to schedule a shutdown for internal inspection at the earliest opportunity and certainly before the total shaft movement exceeded the equivalent of 380 µm (15 mils), approximately 50% over bearing nominal clearance. During a planned shutdown, the customer opened the gearbox for inspection. All the gearbox bearings were severely pitted due to electrostatic discharge and deemed unacceptable for further use. Both compressors were likewise opened for inspection and all bearings and seal rings were found to be pitted. Only one bearing exhibited pitting in the steam turbine. All the distressed bearings and seal rings had to be replaced.

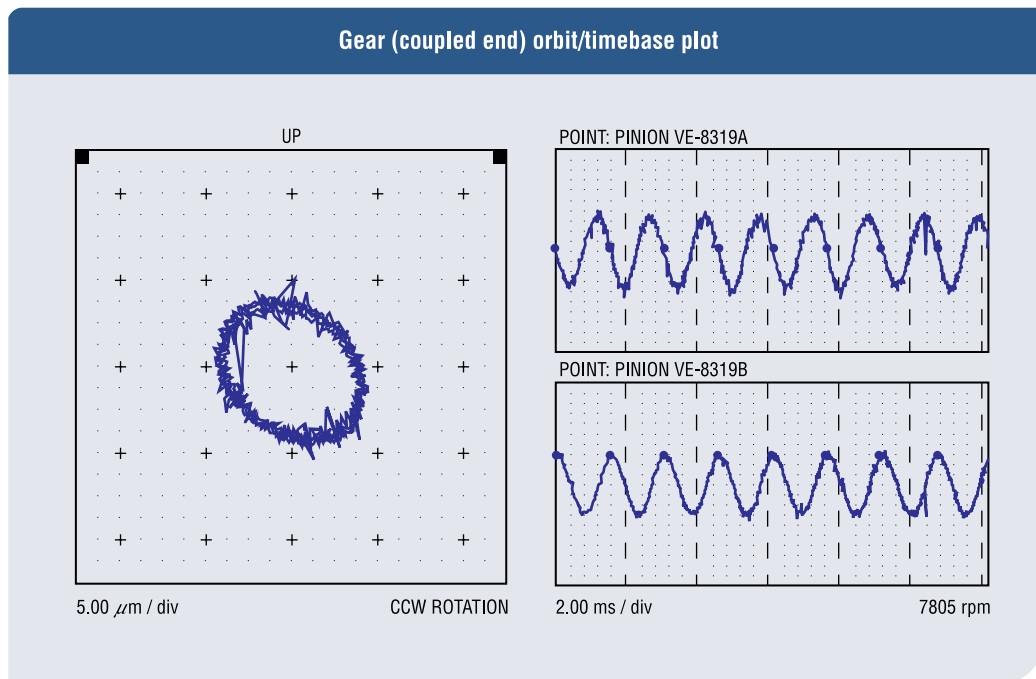
Figure 4.

Figure 4, the orbit/timebase plot at the gearbox low-speed shaft extension (Bearing 5), looks relatively insignificant with the exception of some occasional spiking which could be interpreted as a loose probe or electrical connection in the signal path. As will be seen, this was later attributed to electrostatic discharge rather than loose transducer connections or wiring.

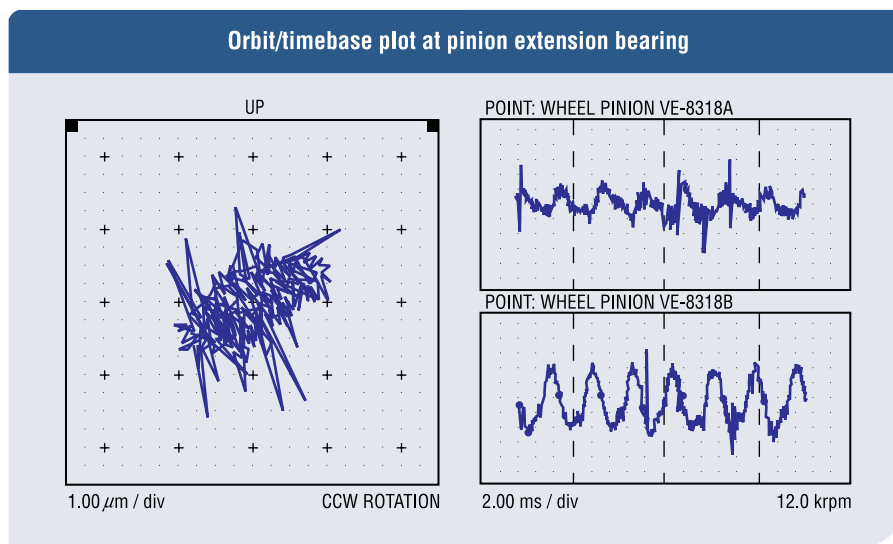
Figure 5.

Figure 5 shows an orbit/timebase plot, this time from the pinion extension bearing (Bearing 8). Note the evidence of pronounced spiking. Also note that the spiking is clearly random and shows both positive and negative excursions, therefore ruling out a scratch in the probe target area.

The presence of random spiking at multiple proximity probes throughout the machine train discounted the

possibility of loose probes or electrical connections in the signal path. Electrostatic discharge was a high probability, particularly in light of the significant shaft centerline motion observed at the gearbox low-speed shaft extension bearing. Recall that gearbox bearings under full load operate at eccentricity ratios of 0.80 to 0.85, often yielding minimum oil film thicknesses of 38 μm (1.5 mils). Thus, in

a machine train that includes a gearbox, electrostatic discharge is likely to be at its worst at the gearbox bearings since this represents the shortest path to ground.

Upon inspection of the grounding brush assembly, one of two brushes did not show contact with the shaft and the other was stuck inside the assembly, preventing contact. The grounding brush assembly was essentially ineffective.
